WALLACE'S WELL, ROBROYSTON

# WALLACE'S WELL

**Location:** Near Wallace Monument, Robroyston

**Client:** Glasgow City Council

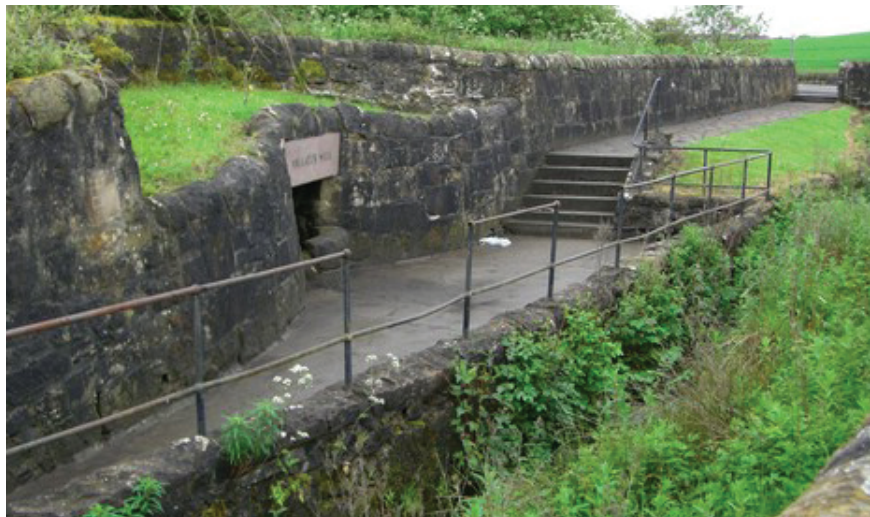
Before

Wallace's Well is located in a rural location in Robroyston, Glasgow. The monument dates back to 1900 and marks the place where Scotland's national hero, William Wallace, was arrested in 1305. It is said William Wallace took his last drink as a free man from the site of the well. Due to years of neglect and the building of a housing development on the land surrounding the site the well and its surrounding masonry walling had fallen into disrepair.

1. Remove vegetation from walling and coat with biocide.
2. Rake out and re-point with lime mortar all paving, walling and the footbridge.
3. Recover original stone from stream and clean
4. Using recovered stone and reclamation stone rebuild all damaged walling
5. Complete all works in time for the annual memorial in August

1. Site visit
2. Tender submission
3. Material procurement, i.e. sourcing of random rubble walling stone to match existing
4. Production of programme of works, methodology statement and H&S documentation including risk assessments, method statements and COSSH reports
5. Sifting original stone from stream and cleaning for reuse
6. Removing vegetation from rubble wall, power wash clean and apply biocide to discourage re-growth
7. Rebuild damaged wall
8. Rake out and re-point all boundary walls
